## CHAPTER III

# Achieving Seismic Safety in Buildings

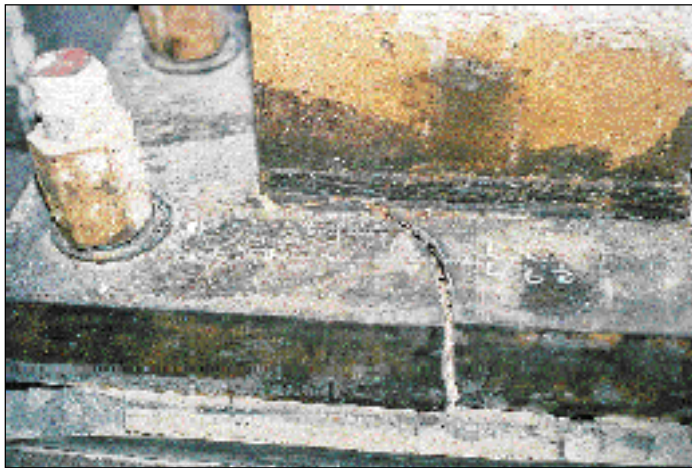
**Figure 15.** A 4-inch-thick steel plate supporting the base of a column at the Oviatt Library at CSU Northridge. The plate fractured when the building was violently shaken.

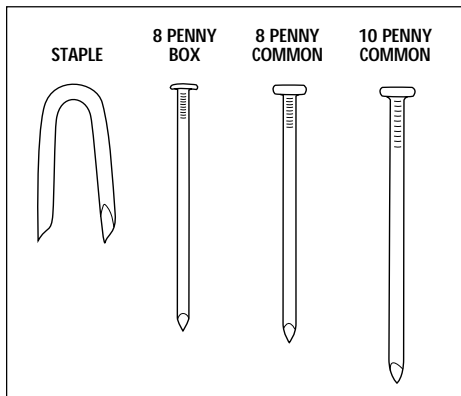
**Figure 17. Smaller box nails and staples were routinely substituted for stronger common nails to reduce construction costs, also reducing earthquake resistance.**

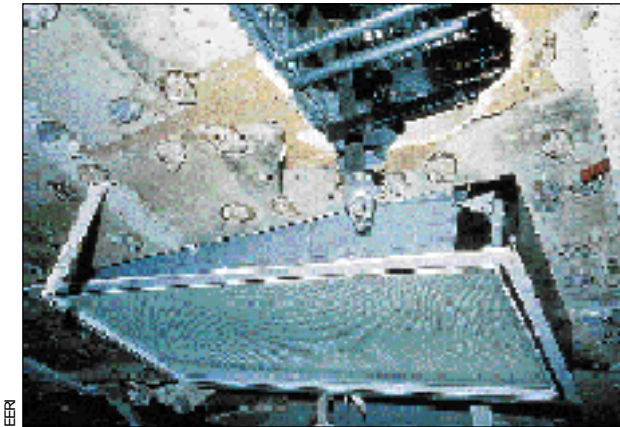
Architects are primarily responsible for the seismic safety of architectural elements in buildings as well as the coordination of architectural, structural, civil, mechanical, and electrical systems. Failures commonly occur during earthquakes because different building systems are not adequately coordinated. For example, fire sprinkler heads are sheared off by swinging ceiling systems; vents fall because they are not attached to ceilings; pipes leak when partitions are racked; large window panes break because their frames are not designed to accommodate building movements; and columns shear when partitions keep them from bending (see Figure 18).

**Figure 18.** When a ceiling panel (since removed) struck this sprinkler head during the earthquake, the pipe sprung a leak, causing extensive damage.

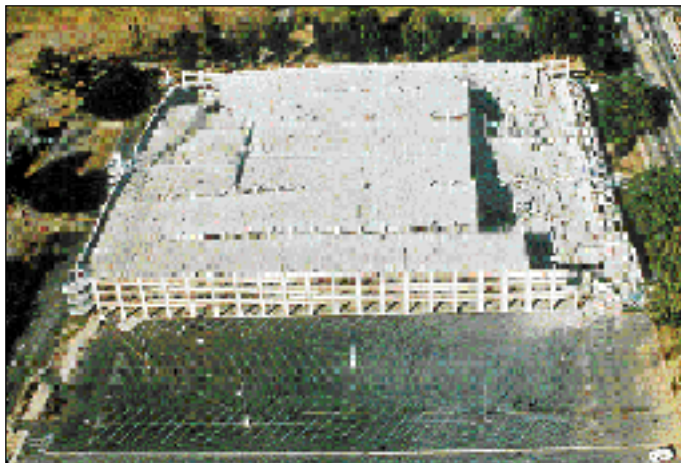
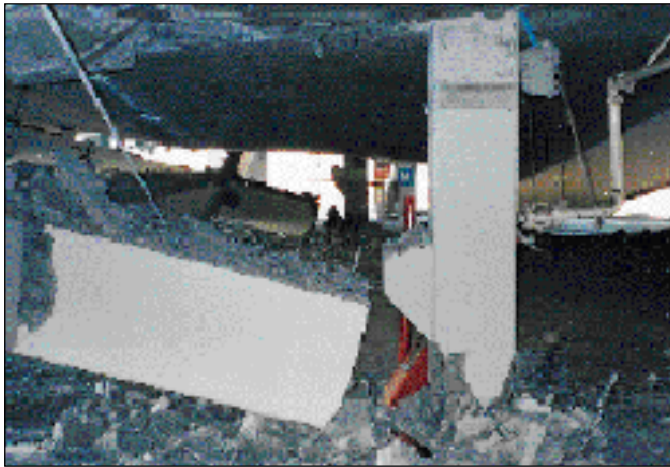
**Figure 19. Constructed in 1991, this CSU Northridge parking structure collapsed when interior columns failed.**

**Figure 20.** Interior columns failed and girders fell off supports in this CSU Northridge parking structure.

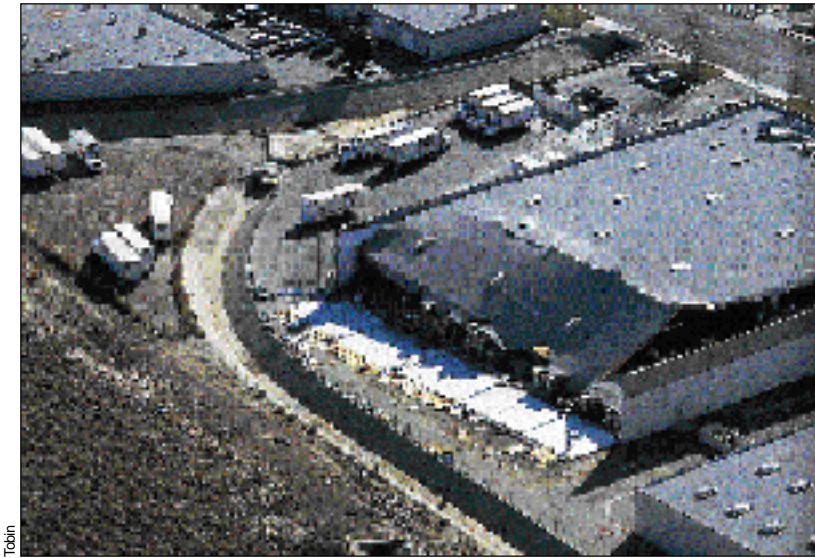
**Figure 22.** This industrial tilt-up building had its roof and wall partially collapse.

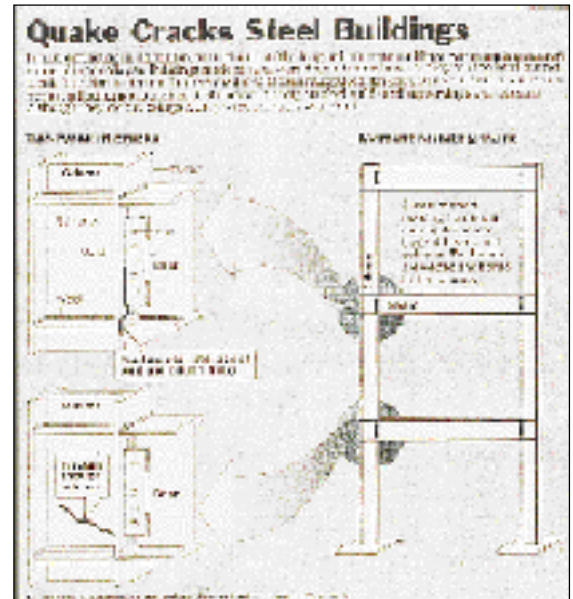
**Figure 23.** Though no steel-frame buildings collapsed, cracks in connections have stimulated efforts to substantiate building code requirements.

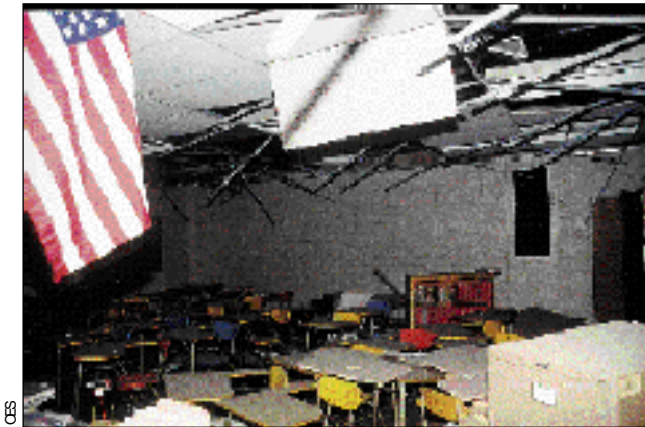
**Figure 25.** Though falling acoustic ceiling tiles like this are not particularly dangerous, falling light fixtures and other heavier elements can be.

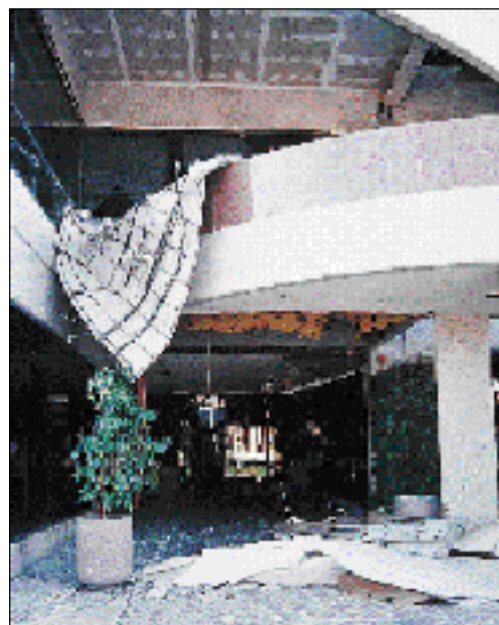
**Figure 26.** Heavy plaster ceilings or soffits can pose serious risks to occupants.

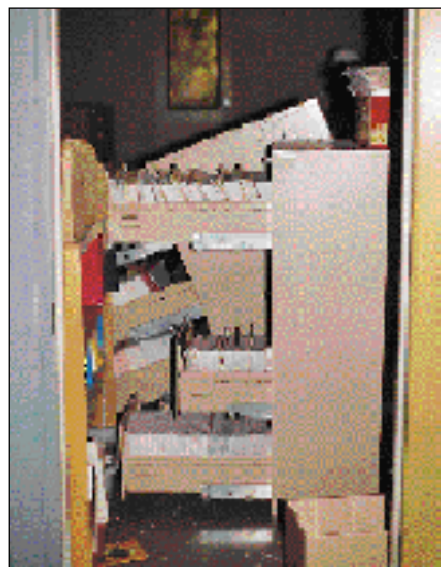
**Figure 27.** Unsecured tall, heavy furniture can strike or trap occupants. Building owners, managers, and occupants are primarily responsible for securing them.

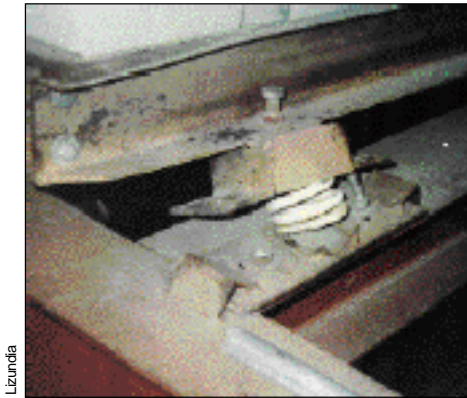
**Figure 28.** Broken supports on heating and ventilating equipment can render this equipment useless.

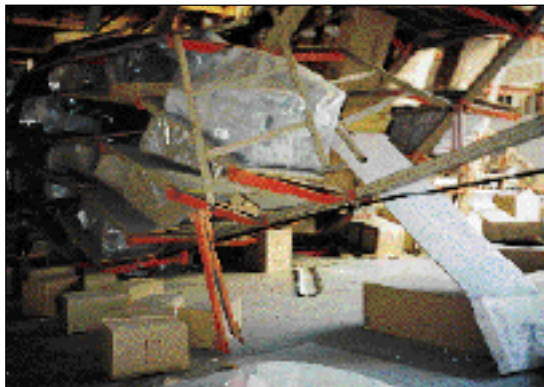
**Figure 29.** Collapsed storage racks would have posed substantial risks to life had this building been occupied during the earthquake.

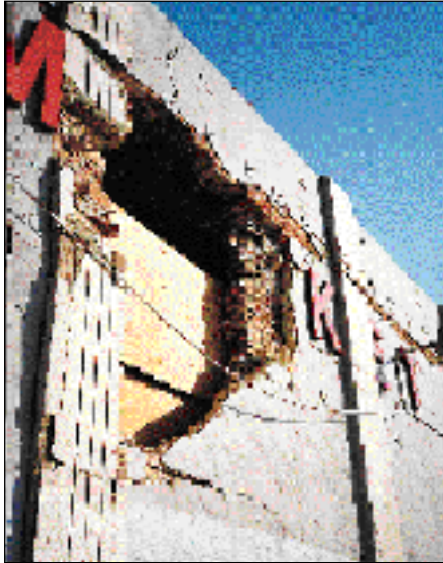
**Figure 35.** Although this retrofitted building lost a few bricks and may be difficult to repair, damage was significantly less than in similar unreinforced buildings. The outer layer of brick was not adequately connected to the inner layers.

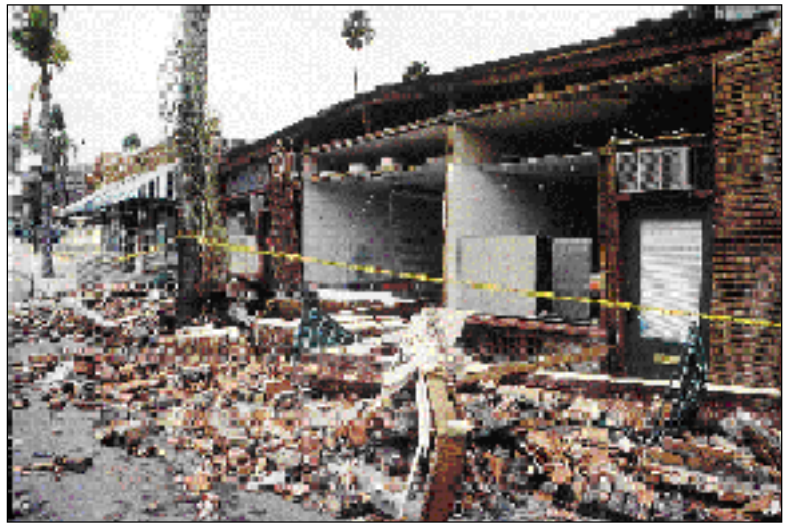
**Figure 36.** The entire facade of this unretrofitted brick building in Fillmore was lost. The city contemplated requiring retrofit measures but concluded as recently as 1993 that they were economically prohibitive.

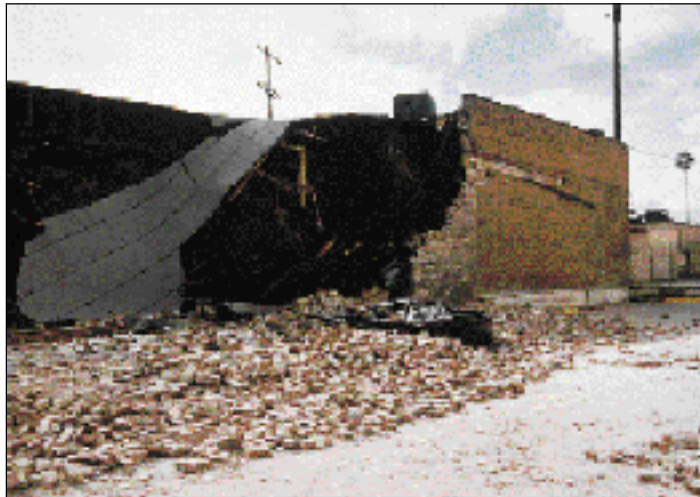
**Figure 37.** This retrofitted brick building collapsed in part because its wall braces were ineffective.

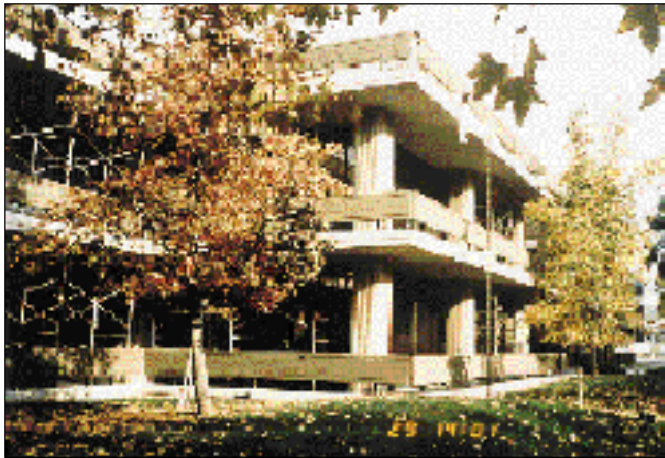
**Figure 40.** This building in Santa Clarita is shown during its 1993 retrofit which was undertaken with minimal disruption to its occupants. The building emerged from the Northridge earthquake with no structural damage.

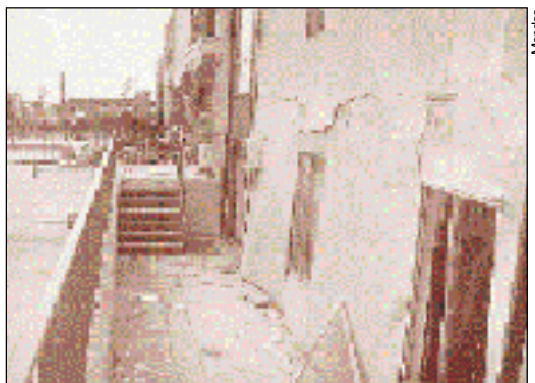
**Figure 41.** Damage from the 1971 earthquake in this apartment was similar to damage in the 17 ghost towns created by the Northridge earthquake.

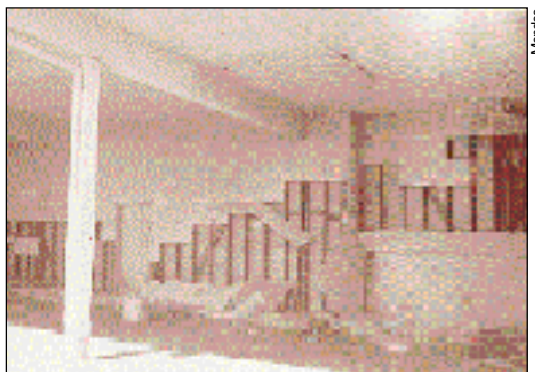
**Figure 42.** Walls in this building were repaired and retrofitted with plywood after 1971. In 1994 it suffered only minor damage.

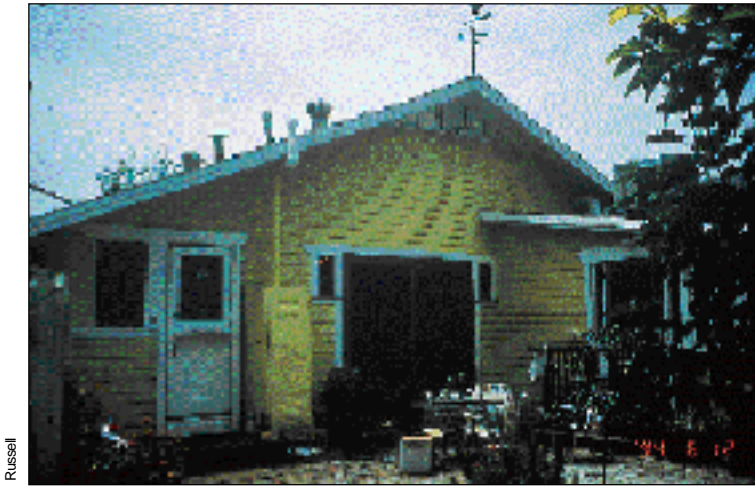
**Figure 43.** This home was retrofitted just prior to the earthquake and sustained far less damage than similar, unretrofitted homes in the neighborhood.

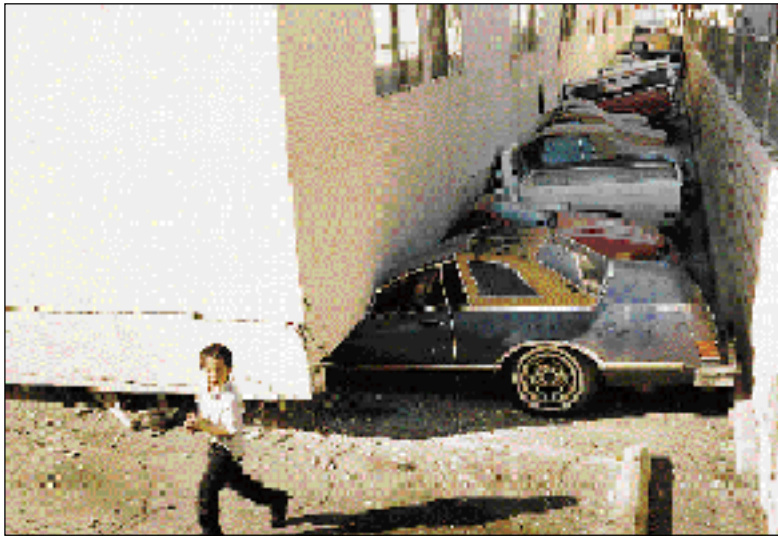
**Figure 45. Older apartments like this with tuck-under parking collapsed because they were poorly braced.**

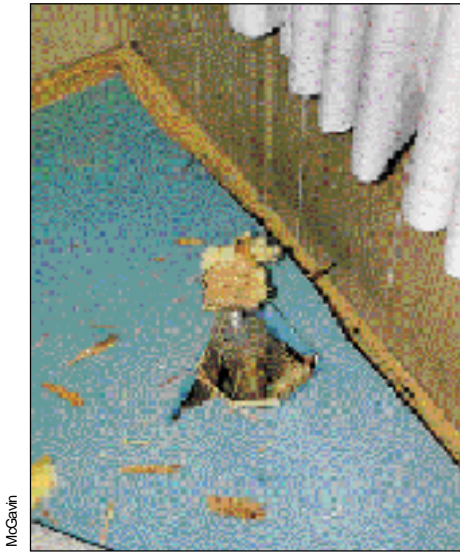
**Figure 48. A steel jackstand pokes up through the floor of a mobile home after it shifted.**

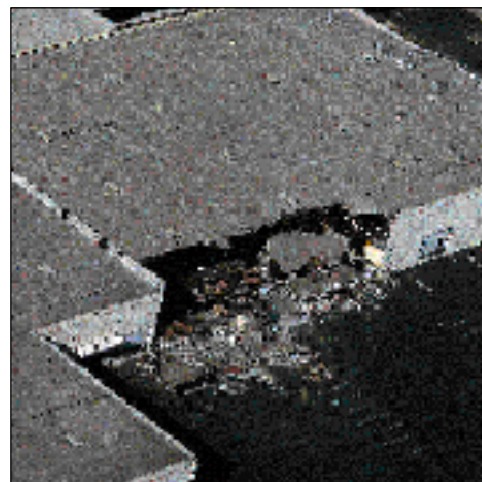
**Figure 49.** Damage to both new and older tilt-up buildings was widespread.

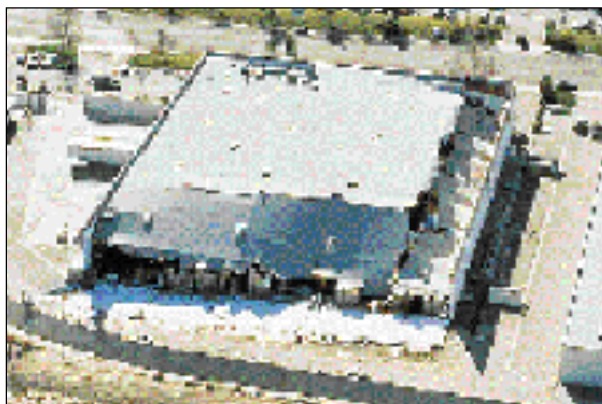
**Figure 50.** Despite changes to the building code made shortly after the 1971 earthquake, failures occurred in tilt-up buildings.

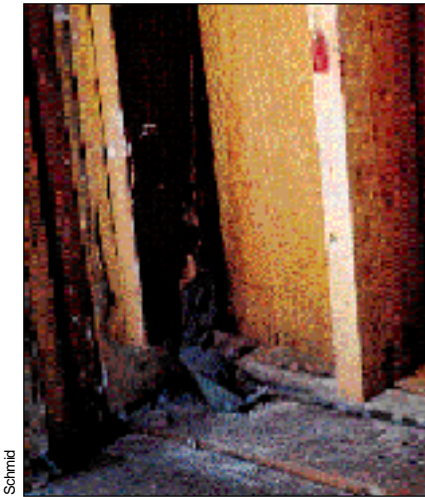
**Figure 51.** This metal connector stretched, distorted, and eventually caused the wood to split.

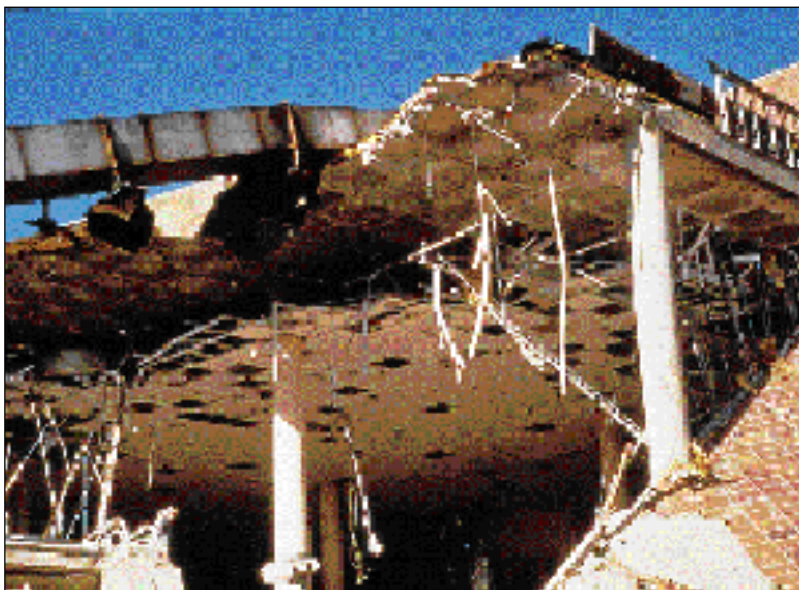
**Figure 52.** Connections between the roof and floor slabs and the columns failed in this collapsed building.

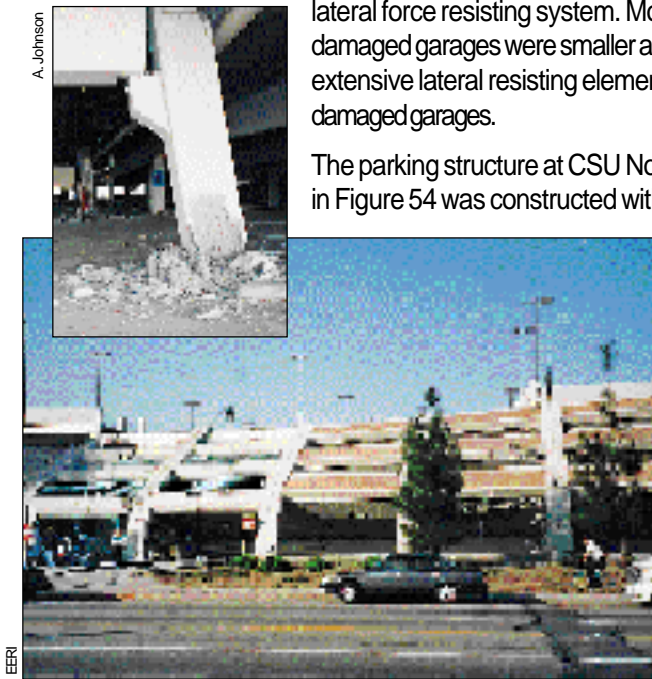
**Figure 54.** This parking structure's exterior frames leaned over when interior columns failed. *Inset, detail.*

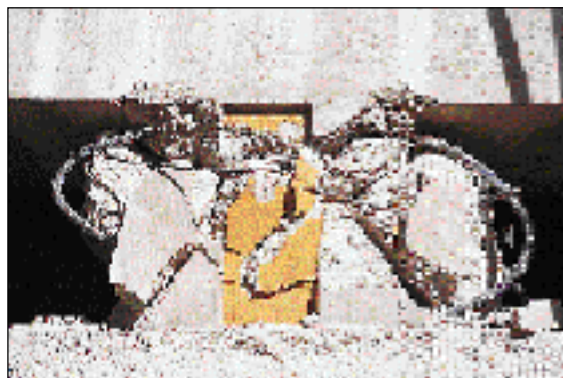
**Figure 55. Short columns in this parking structure failed. Modern building codes now require much more reinforcing steel for such short columns.**

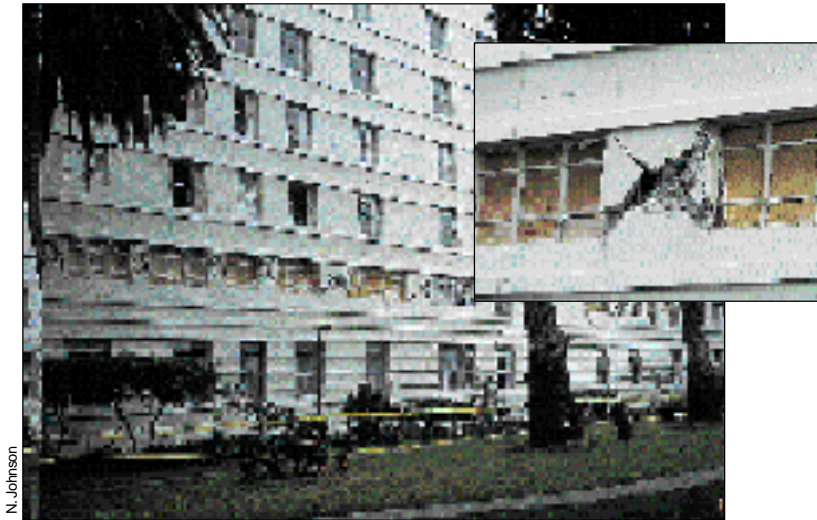
**Figure 58.** This older hospital was severely damaged. Lightly reinforced concrete walls lost much of their strength when X cracks formed. *Inset, detail.*

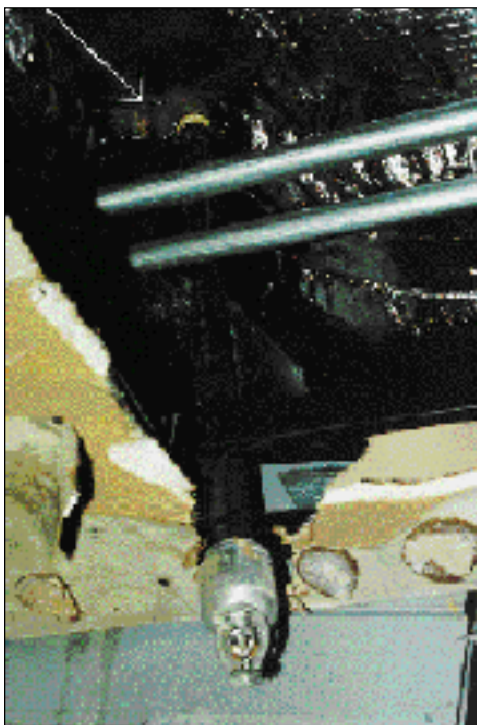
**Figure 59.** Water from failed sprinkler lines produced costly damage and disruption.

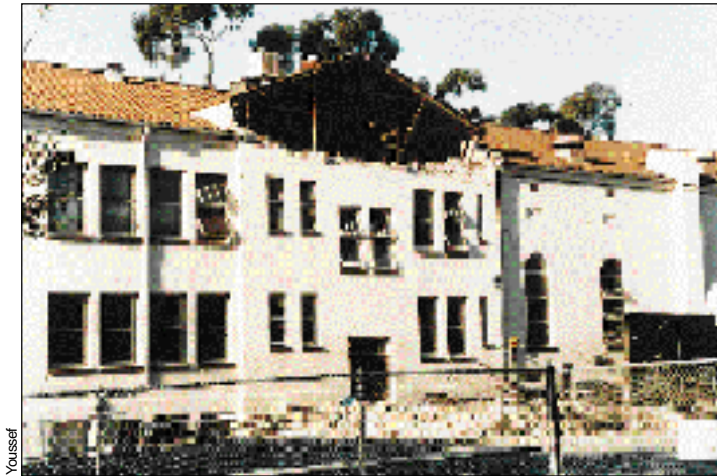
**Figure 66. Life-threatening structural hazards such as this are still allowed in older private schools throughout California. Most of them have been eliminated in our public schools.**
